# **The Warship Hazardous Project Site Report**

## **November 2012.**

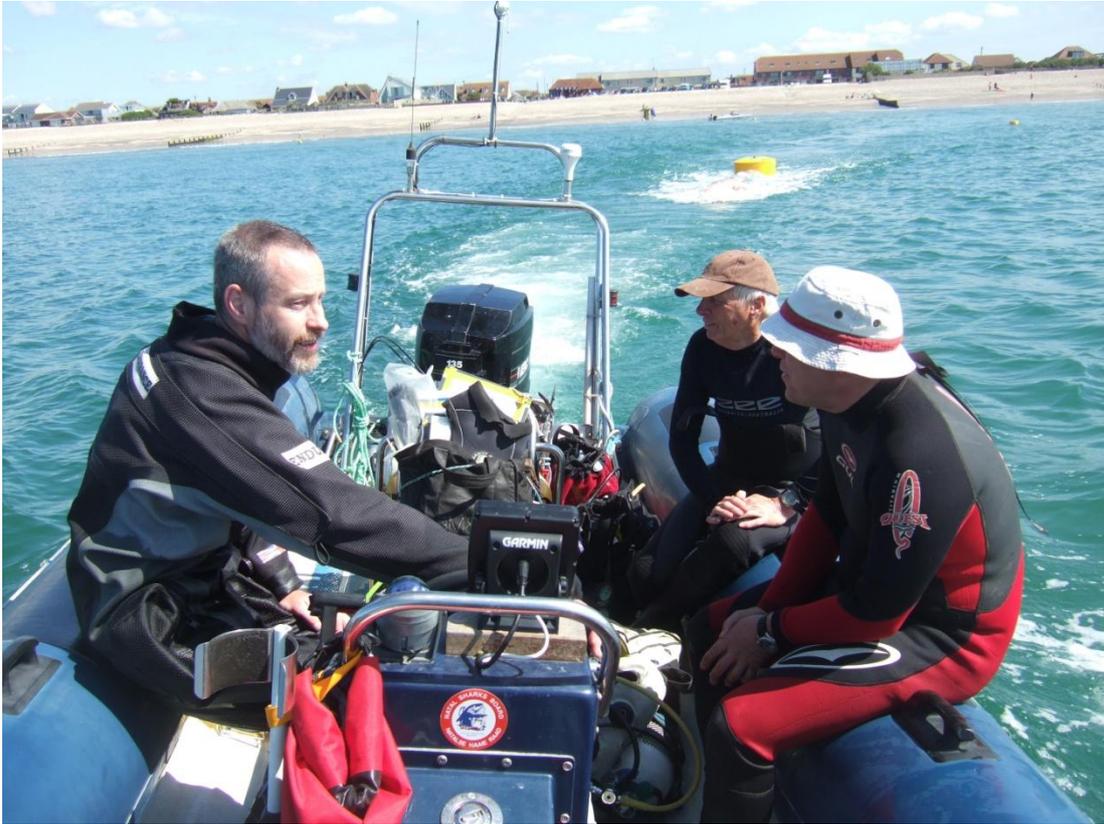
**Figure 2** *Towing the new buoy to site.*

It was not possible to revisit the site again until late July, at which time the riser was located & uncovered back to the joining shackle. The buoy was finally re-sited on the 28<sup>th</sup> July (*see fig. 2*).

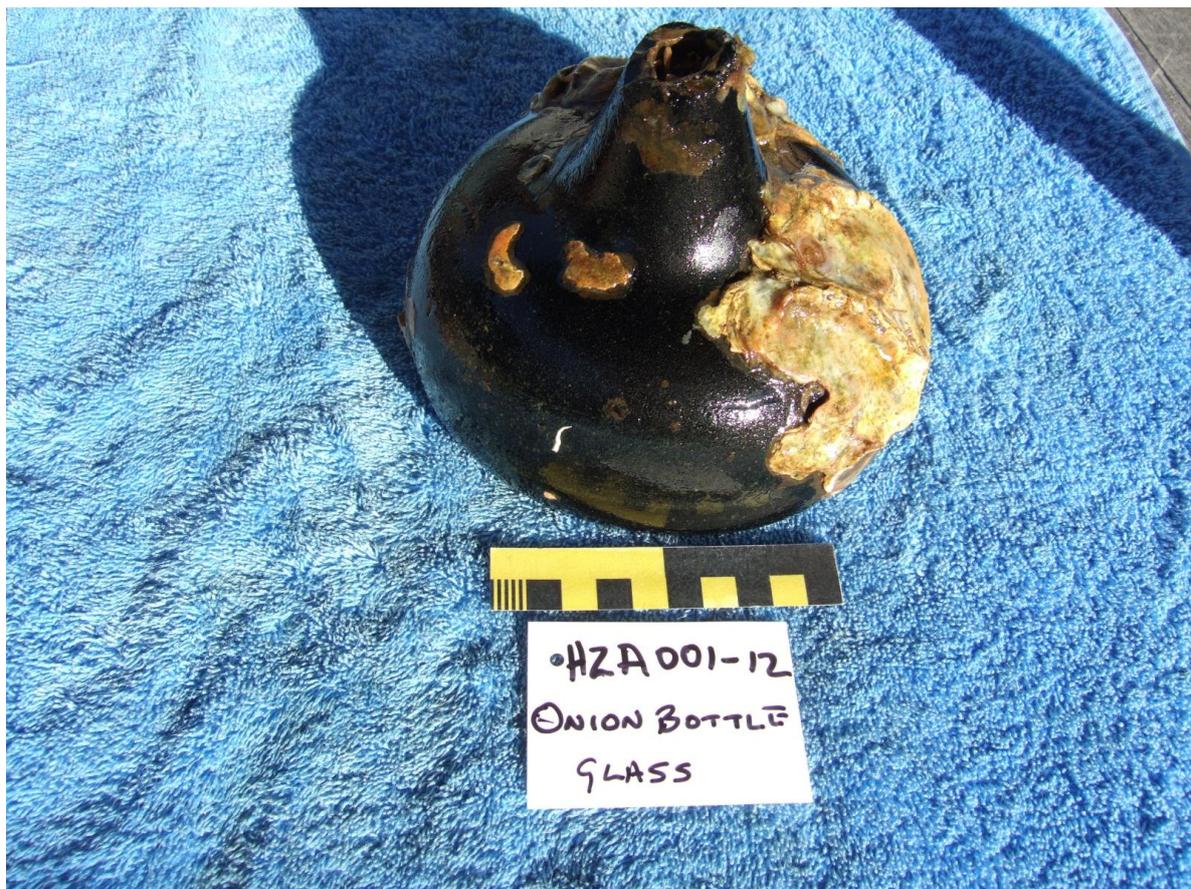
One artefact was recovered from north east of site (*see fig. 3*), this was found at the end of the diving day, in worsening sea conditions, the artefact was found standing on the clay beds. It was only possible to fix a “position approximate” before recovery of the artefact due to conditions & lack of breathing air.

This position when entered on Site Recorder shows it to be at least 10 metres out side the protected area of the wreck site, in the north east quadrant.

**Figure 3** Glass onion bottle, with parts of oyster shell attached, most likely from past uncovering.

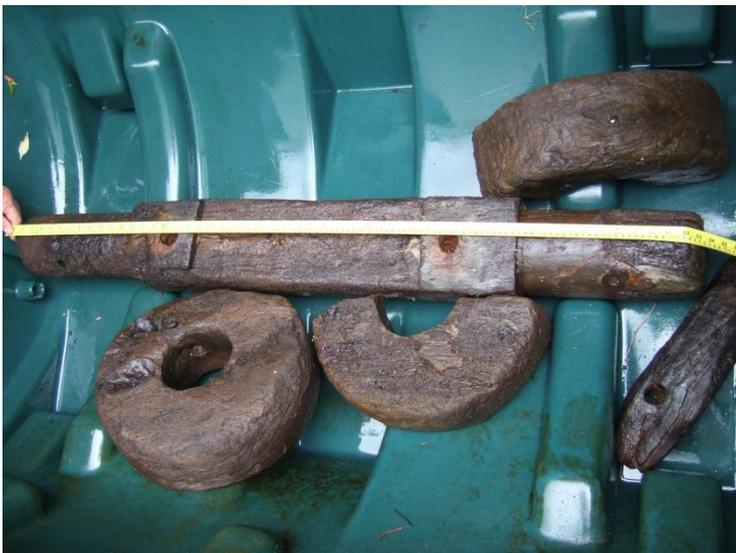
**Figure 4** Taking measurements for tank fabrication.

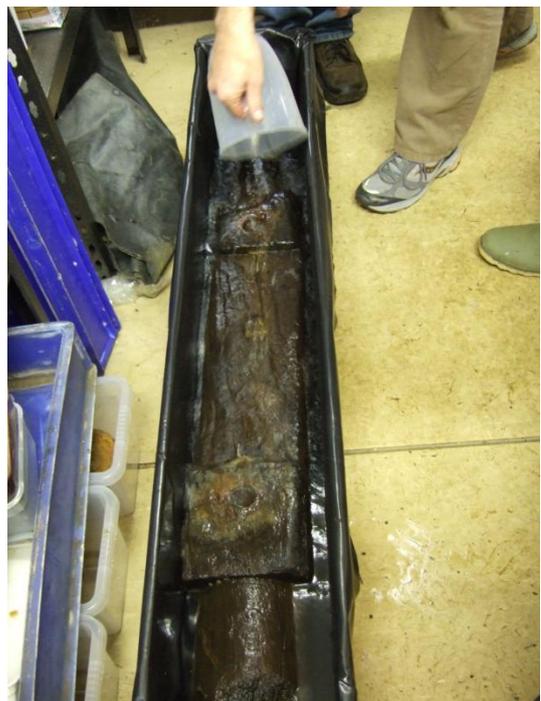
Although it was not possible to carry out a lot of work underwater, a considerable number of hours were devoted to improving the artefact displays, maintenance work on the display building & signage, also work on wet stored artefacts has been progressed, in some cases to packaging & storage, time was spent fabricating tanks (*see fig. 4*) to enable the treatment in PEG of elements of a gun carriage recovered from site previously & held in wet store, these wood artefacts have now been placed in PEG & will be monitored over time (*see fig. 5*).

**Figure 5** Adding Peg to gun carriage axle tank.
