# **The Warship Hazardous Project Site Report**

## **November 2013.**

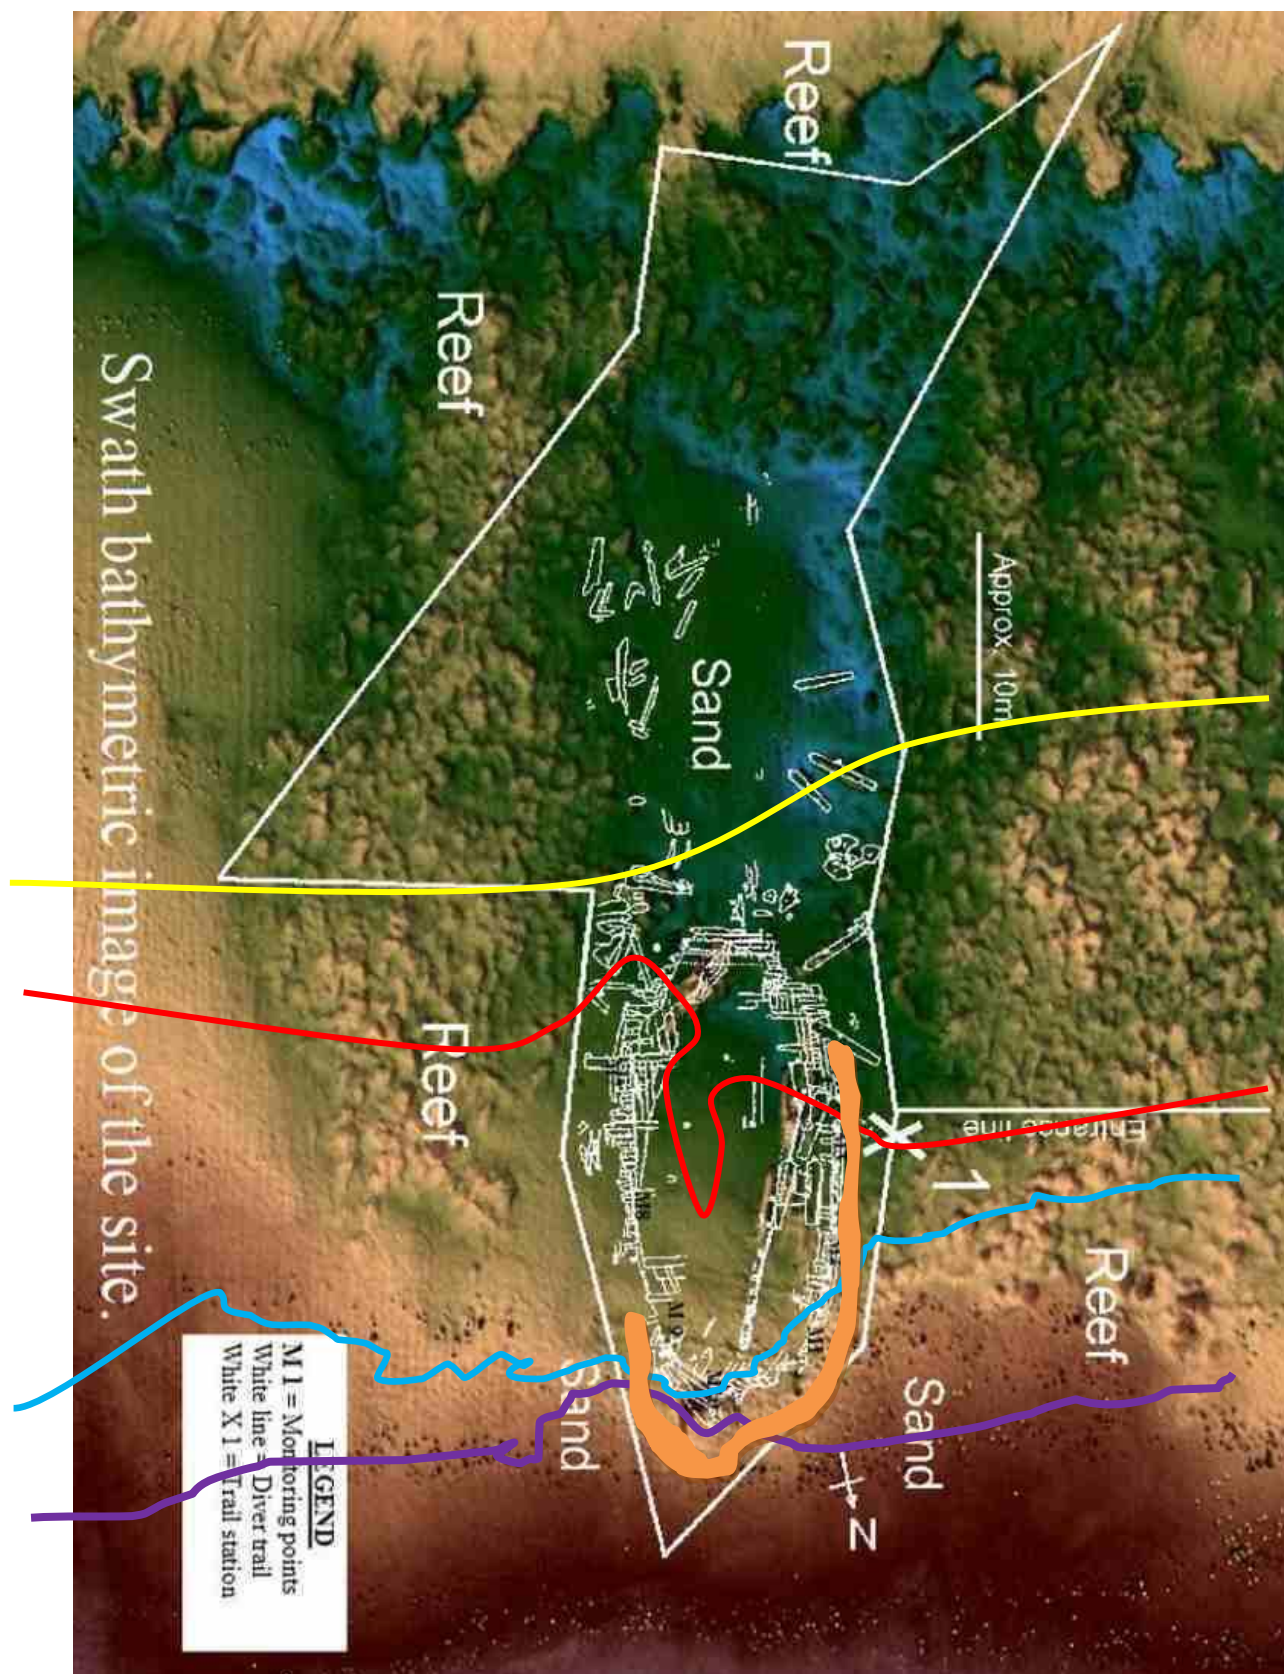
No loose artefacts were recovered from the main site area, or in the gullies north east of the main site. The diver trail cables were found to be completely buried under sand overburden, save a short section just north, east & west of the beak, due to a very localized scour starting at the pile of three large cannon up the west side of the hull timbers, around the beak & for a very short distance down the east side frames (*see fig. 1 light brown zone*).

**Figure 1.** showing site plan & diver trail overlain on swath bathymetric survey results.

*Yellow line = 2008 sand movement from the south to the north.*

*Red line = 2009 sand movement from the south to the north.*

*Blue line = sand movement from the south to the north as at 17<sup>th</sup> October 2010.*

*Purple line = sand movement from the south to the north as at 21<sup>st</sup> August 2011.*

*Light brown = 2013 localized scour.*

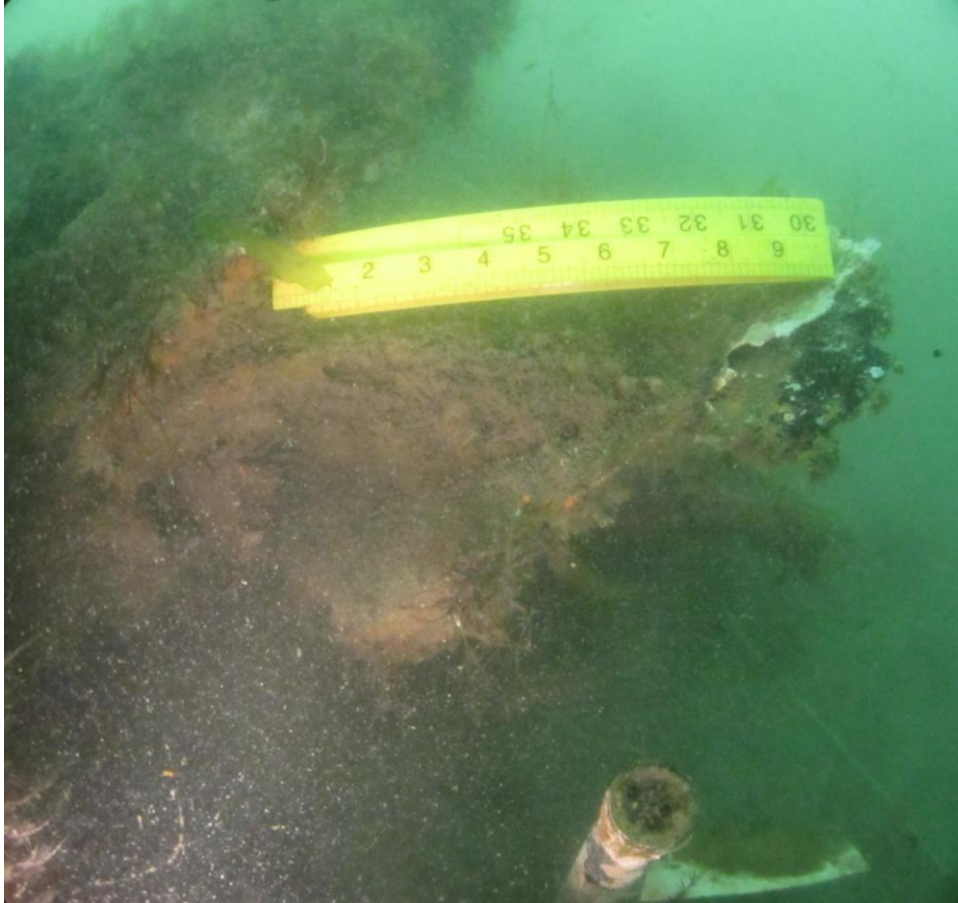
The timber of the beak shows considerable degradation from the activity of gribble worm on the exposed high points, the lead sheeting sandwiched between the timber lay up of this area appears to be more exposed also.

A new monitoring point M10-13 was established just north of the beak to replace the one on the beak which was lost due to gribble worm activity, this new datum is approximately 160mm below the original, therefore all comparisons with previous years measurements should be adjusted by + this amount.

**Figure 2.** *Beak showing new monitoring point & lead sandwiched between timbers.*

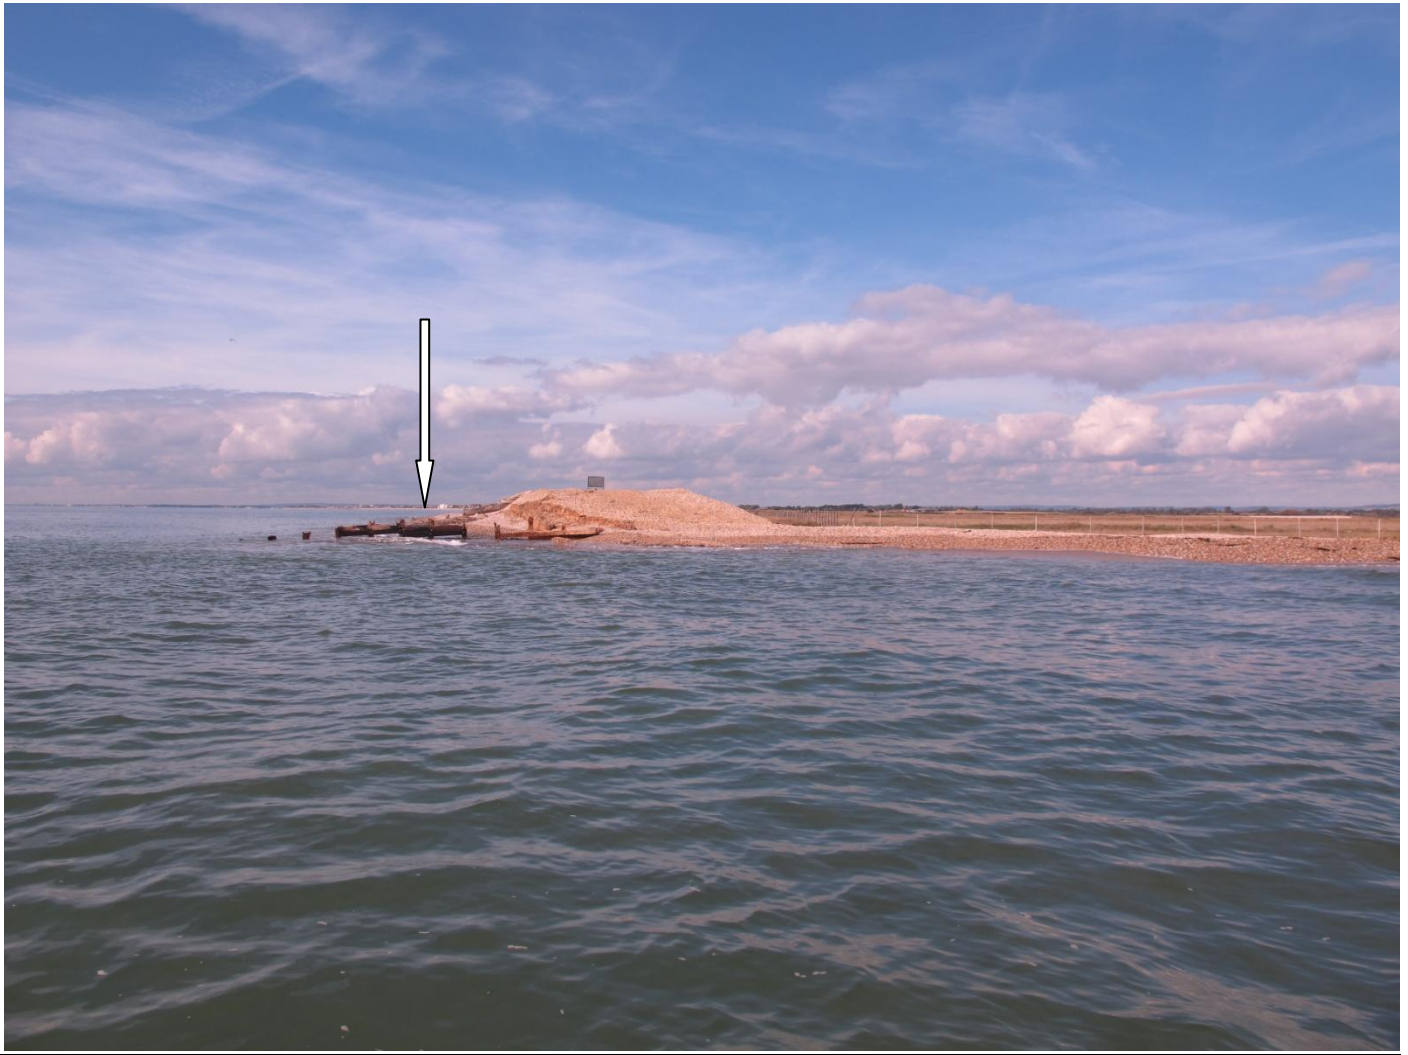
Their work involves building large rock revetments, & replenishing the beach between with thousands of tons of sand & shingle, dredged from beyond the Isle of Wight, also opening up an area of coastal defence to form an inland flood plain (*see fig.3*), at the time of writing this report that work has been largely completed. However the Chichester district council have now submitted a plan to collect shingle that has been thrown up on top of the seawall over the last several years, between the ends of East Bracklesham Drive & Shore Road East Wittering (*the area in front of Hazardous*) & transport it further westward along the bay. According to council figures, this amounts to the movement of some 12000 cubic metres of material, which will be moved between December & February. Future monitoring on & around the wreck site next season may well show up some major changes to sediment levels.

**Figure 3.** View from within the new flooded area looking southwest towards Hazardous approximately a mile away.
