# **The Warship Hazardous Project Site Report**

## **November 2015.**

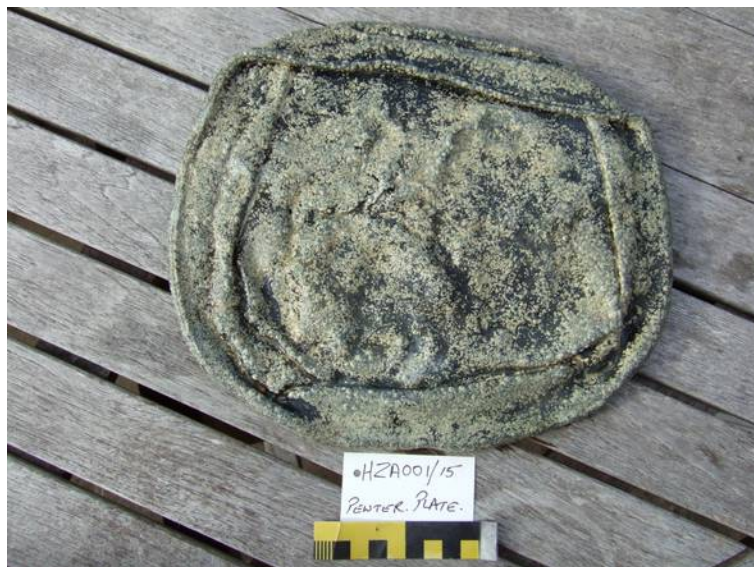
However the east side frames from this point heading south appear more uncovered since last year, alongside the cannon ball mound on the outside of the hull frames a number of heavy timbers have now become visible, this indicates an estimated drop in seabed levels at this point of around 300mm, sticking out from beneath one of these timbers was a complete pewter plate which has been crushed flat, see *Figure 4*.

*Figure 4. Pewter plate recovered 26<sup>th</sup> April 2015.*

This artefact was measured in & the position marked to enable extra measurements to be taken in better visibility, it was then recovered to the surface, before it was lost from the site. It was not possible to determine in the poor visibility whether these timbers are “in situ” or have moved to their present position over winter, further evaluation will be undertaken when conditions improve.

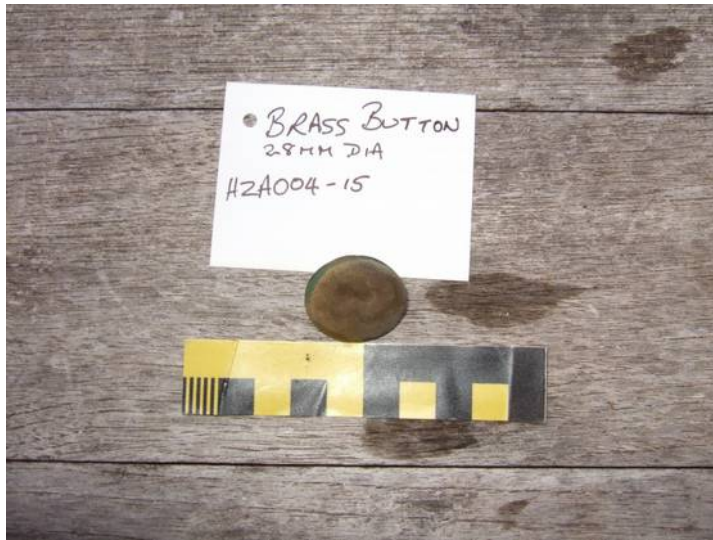
*Figure 5.*

Various shards of glass, earthenware pottery & some animal bone were observed around the site at different times, some textile/leather was also found partially exposed close to the exposed barrels, however as it was in a fragile condition & would require excavation to recover in its entirety (*we do not as yet have an excavation licence*) it was therefore carefully re-buried, it is hoped it will remain in place over winter. Three further at risk artefacts found on the seabed, were recovered from the site this season (see *figures 5 to 7*),
