The Warship Hazardous Project Site Report

November 2016.

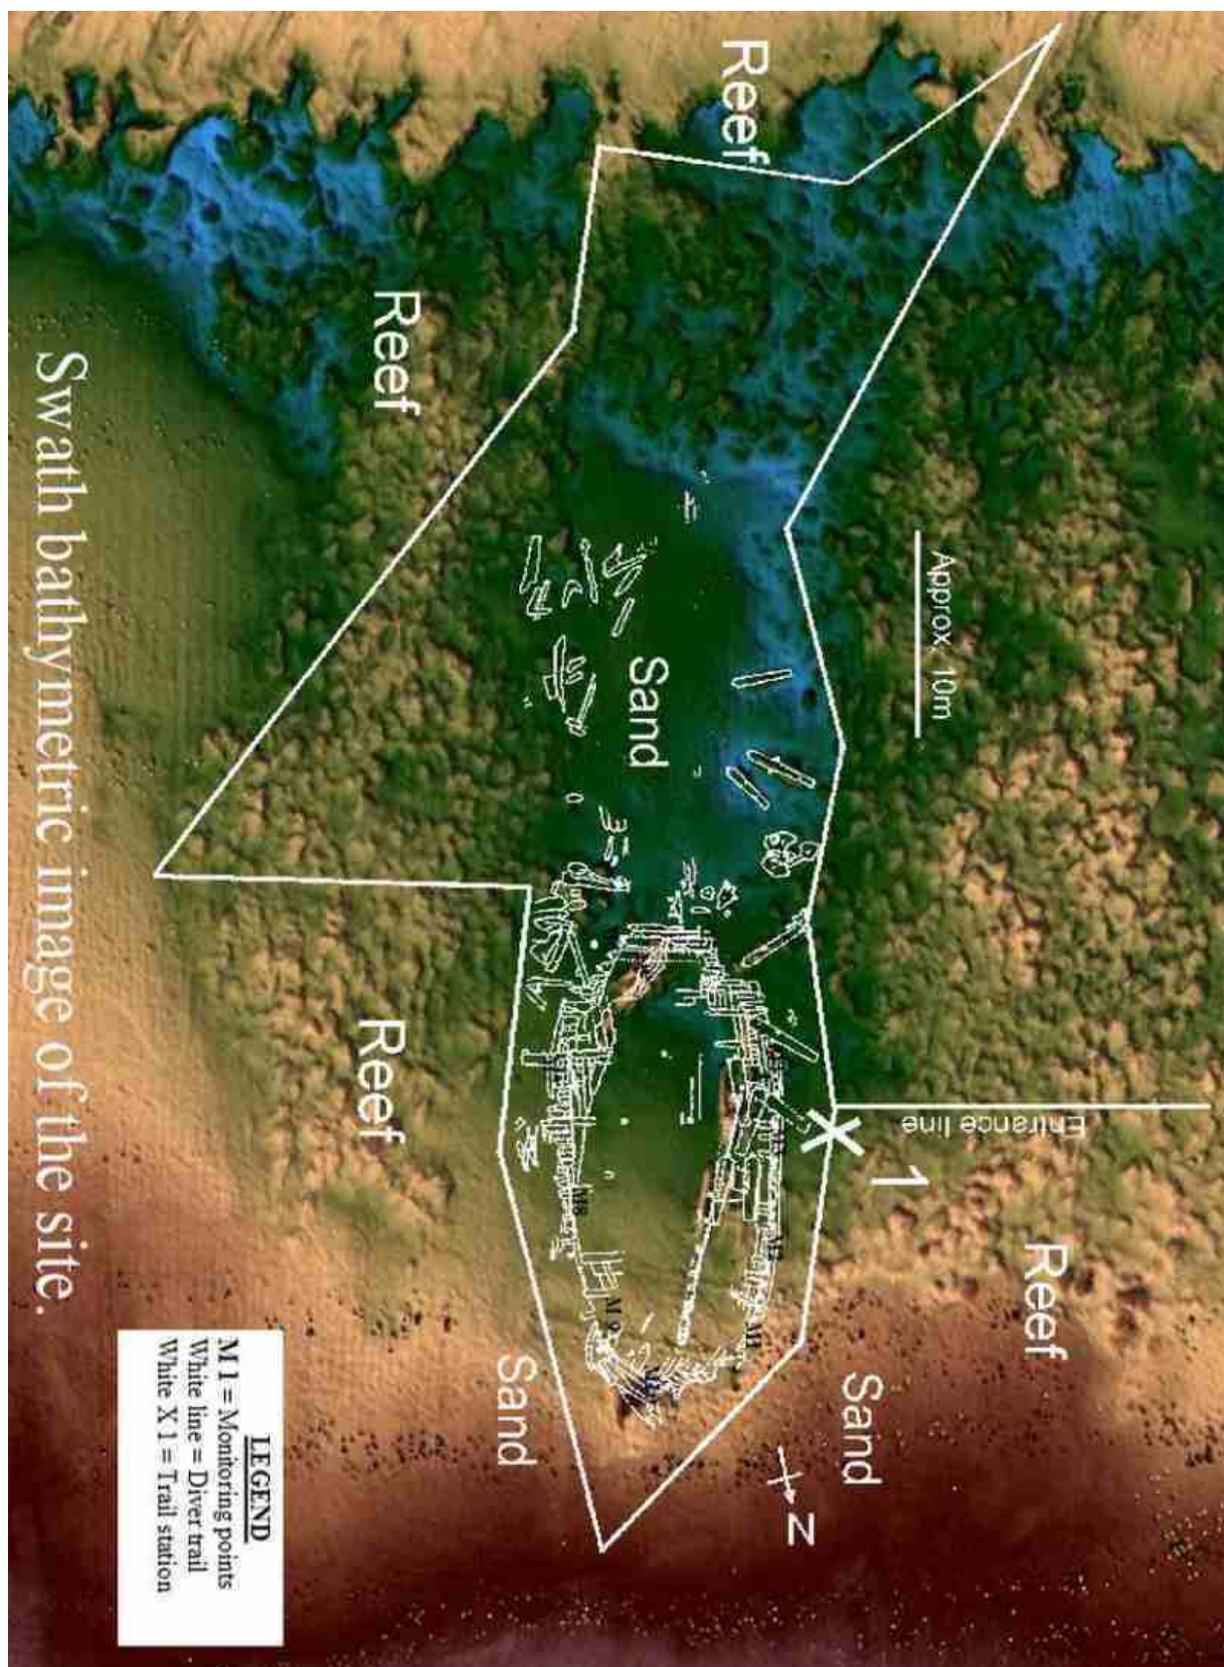
The cannon ball mound & the three large cannon stand well proud of the seabed to a greater extent than last year; along with substantial loss of sand overburden around the line of guns, to the south of the break in the hull remains (*see Figures 1 to 3 showing prevailing seabed movements over recent years*).

Figure 1. showing site plan & diver trail overlain on past swath bathymetric survey results..

Yellow line = 2008 sand movement from the south to the north.
 Red line = 2009 sand movement from the south to the north.
 Blue line = sand movement from the south to the north as at 17th October 2010.
 Purple line = sand movement from the south to the north as at 21st August 2011.
 Light brown = 2013 localized scour.

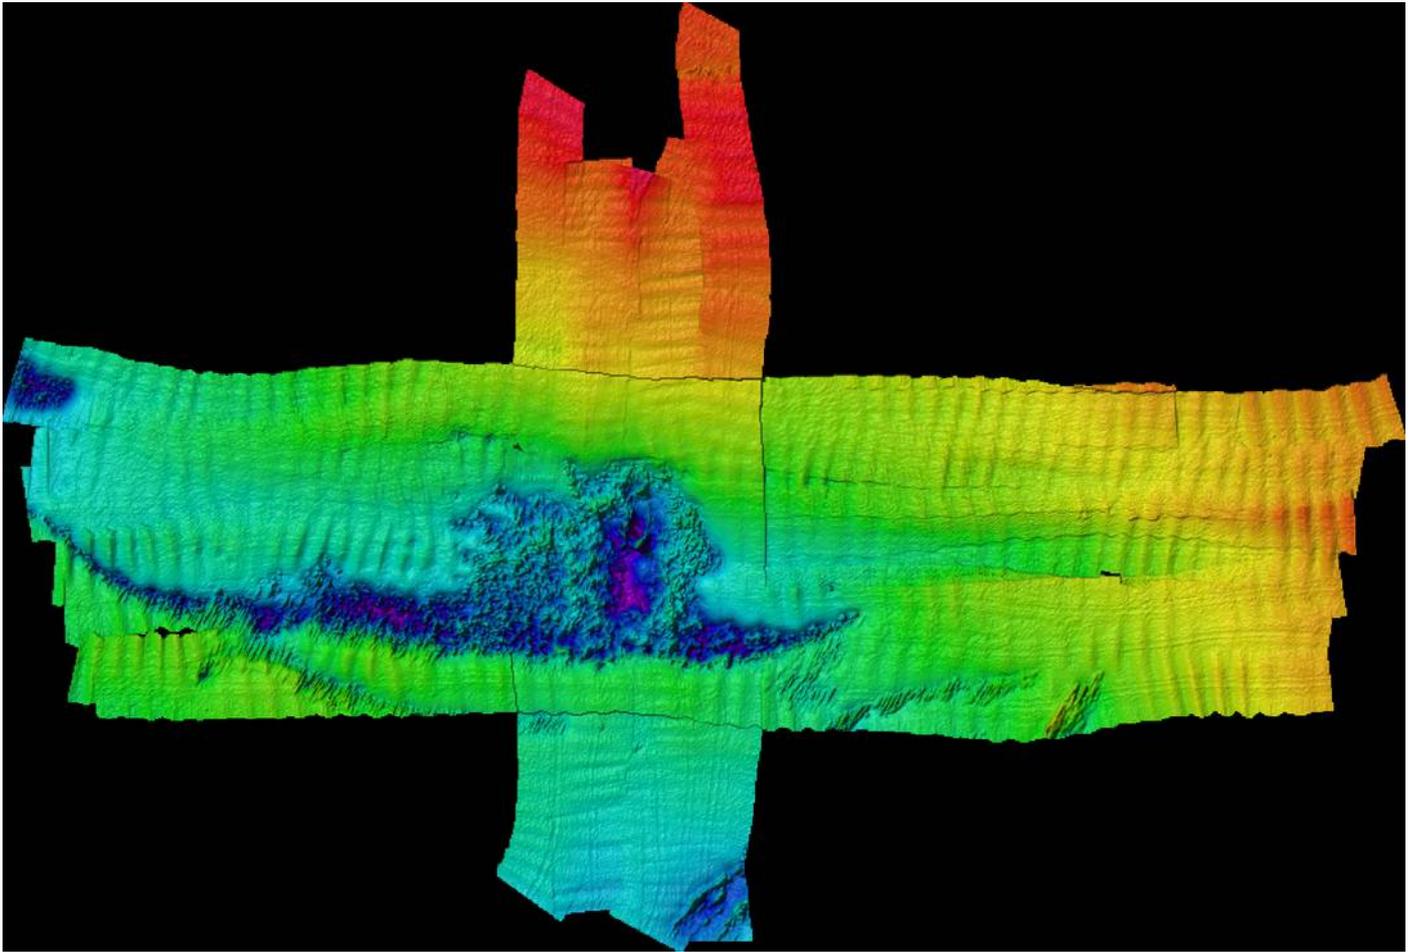
Figure 2. Swath bathymetric survey results July 2014. North up. Showing erosion over the site & out to the west.

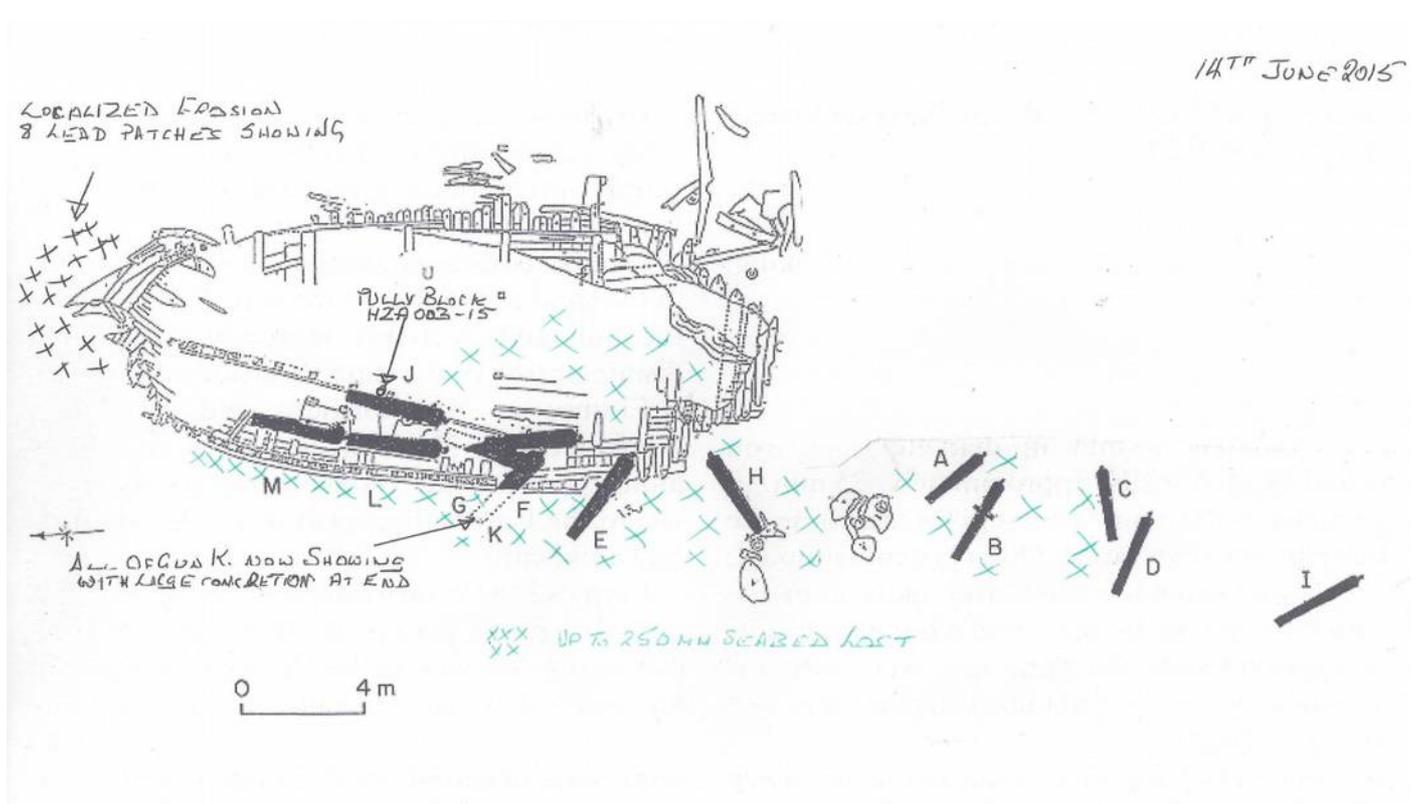
Figure 3 Seabed changes June 2015, areas of reduction marked xx, xx.
