# **The Warship Hazardous Project Site Report**

## **November 2016.**

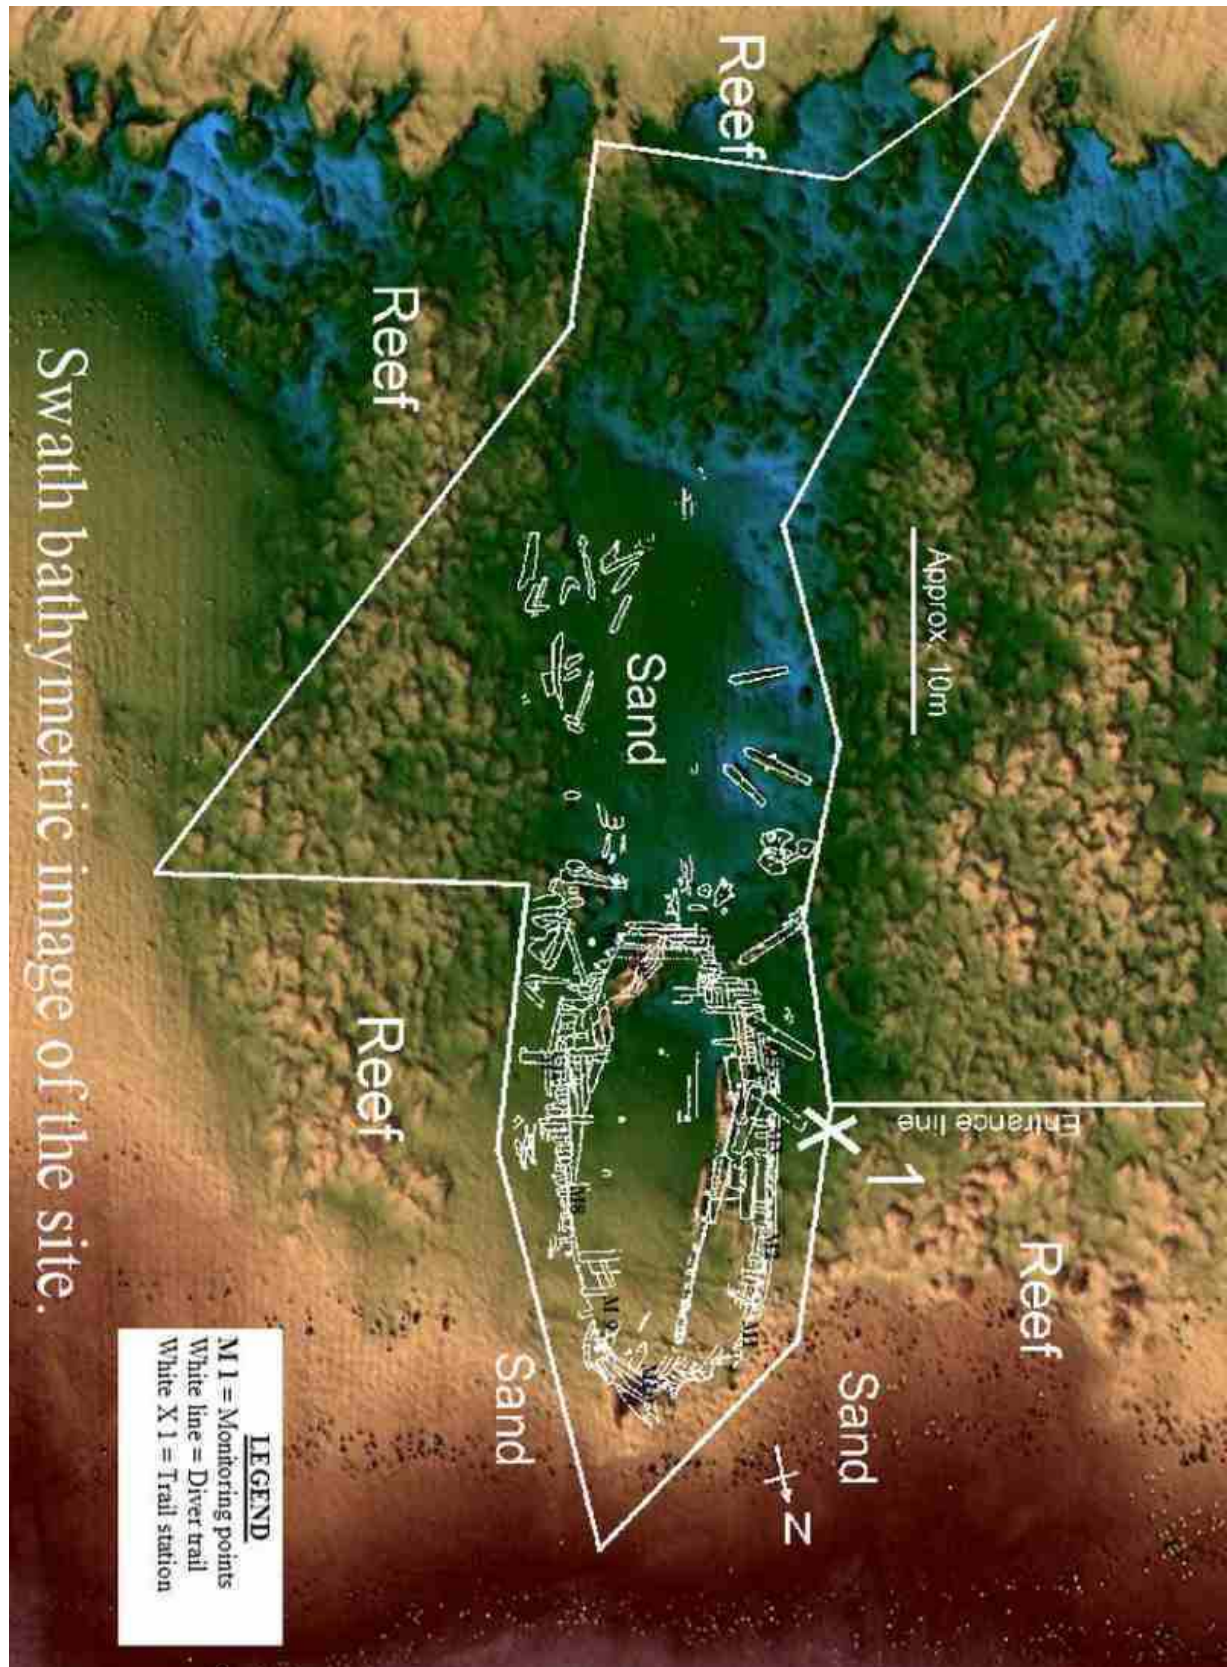
**Swath bathymetric image of the site.**

*Figure 1. showing site plan & diver trail overlain on past swath bathymetric survey results..*

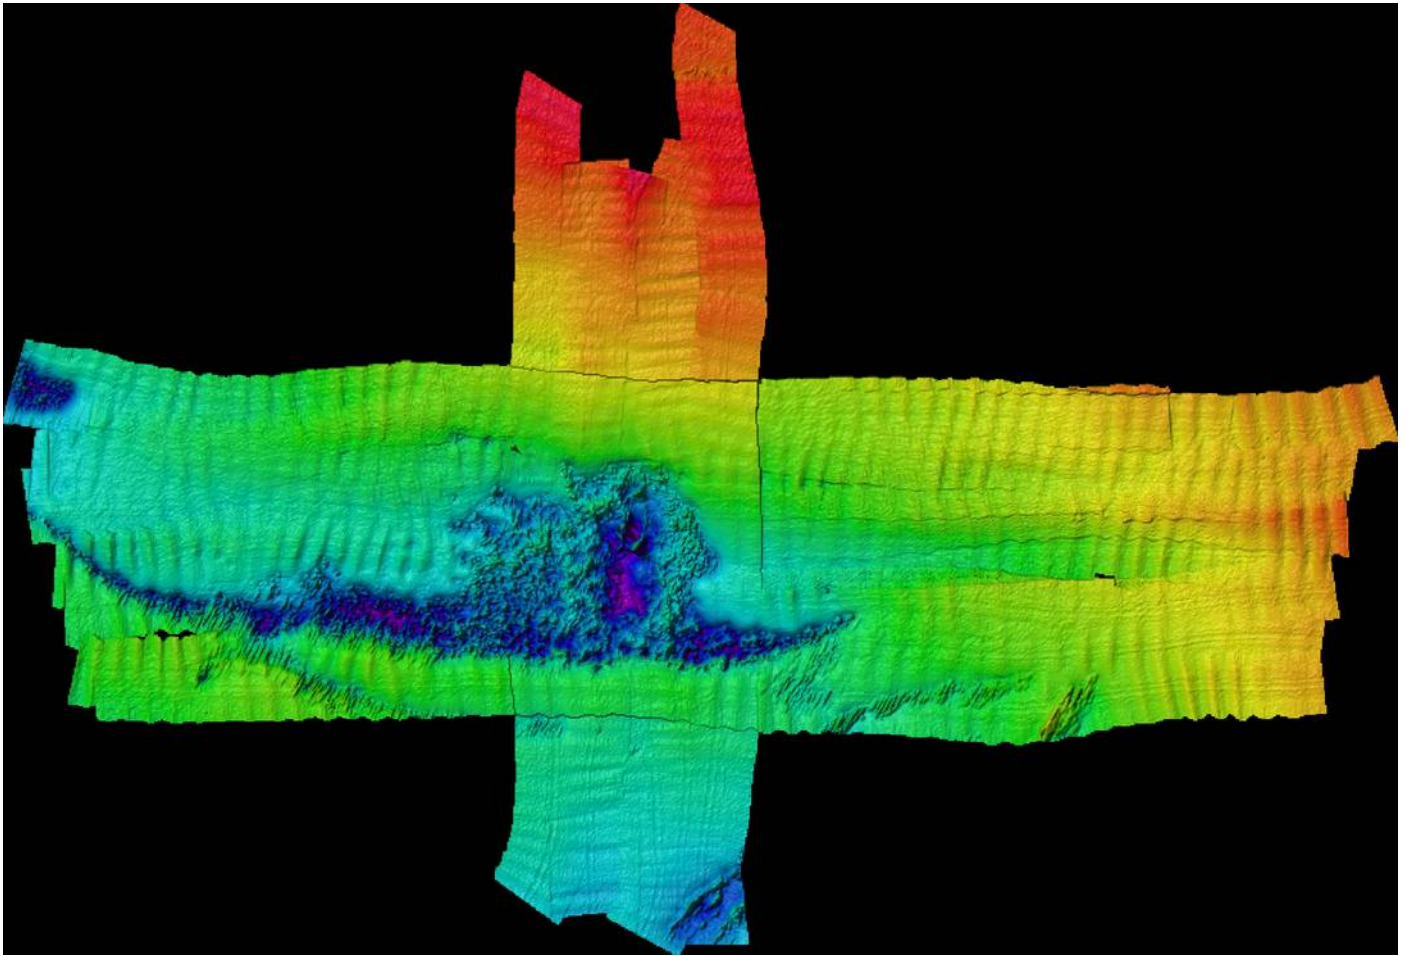
The cannon ball mound & the three large cannon stand well proud of the seabed to a greater extent than last year; along with substantial loss of sand overburden around the line of guns, to the south of the break in the hull remains (*see Figures 1 to 3 showing prevailing seabed movements over recent years*).

Yellow line = 2008 sand movement from the south to the north.  
 Red line = 2009 sand movement from the south to the north.  
 Blue line = sand movement from the south to the north as at 17<sup>th</sup> October 2010.  
 Purple line = sand movement from the south to the north as at 21<sup>st</sup> August 2011.  
 Light brown = 2013 localized scour.
