The Warship Hazardous Project Site Report - October 2010

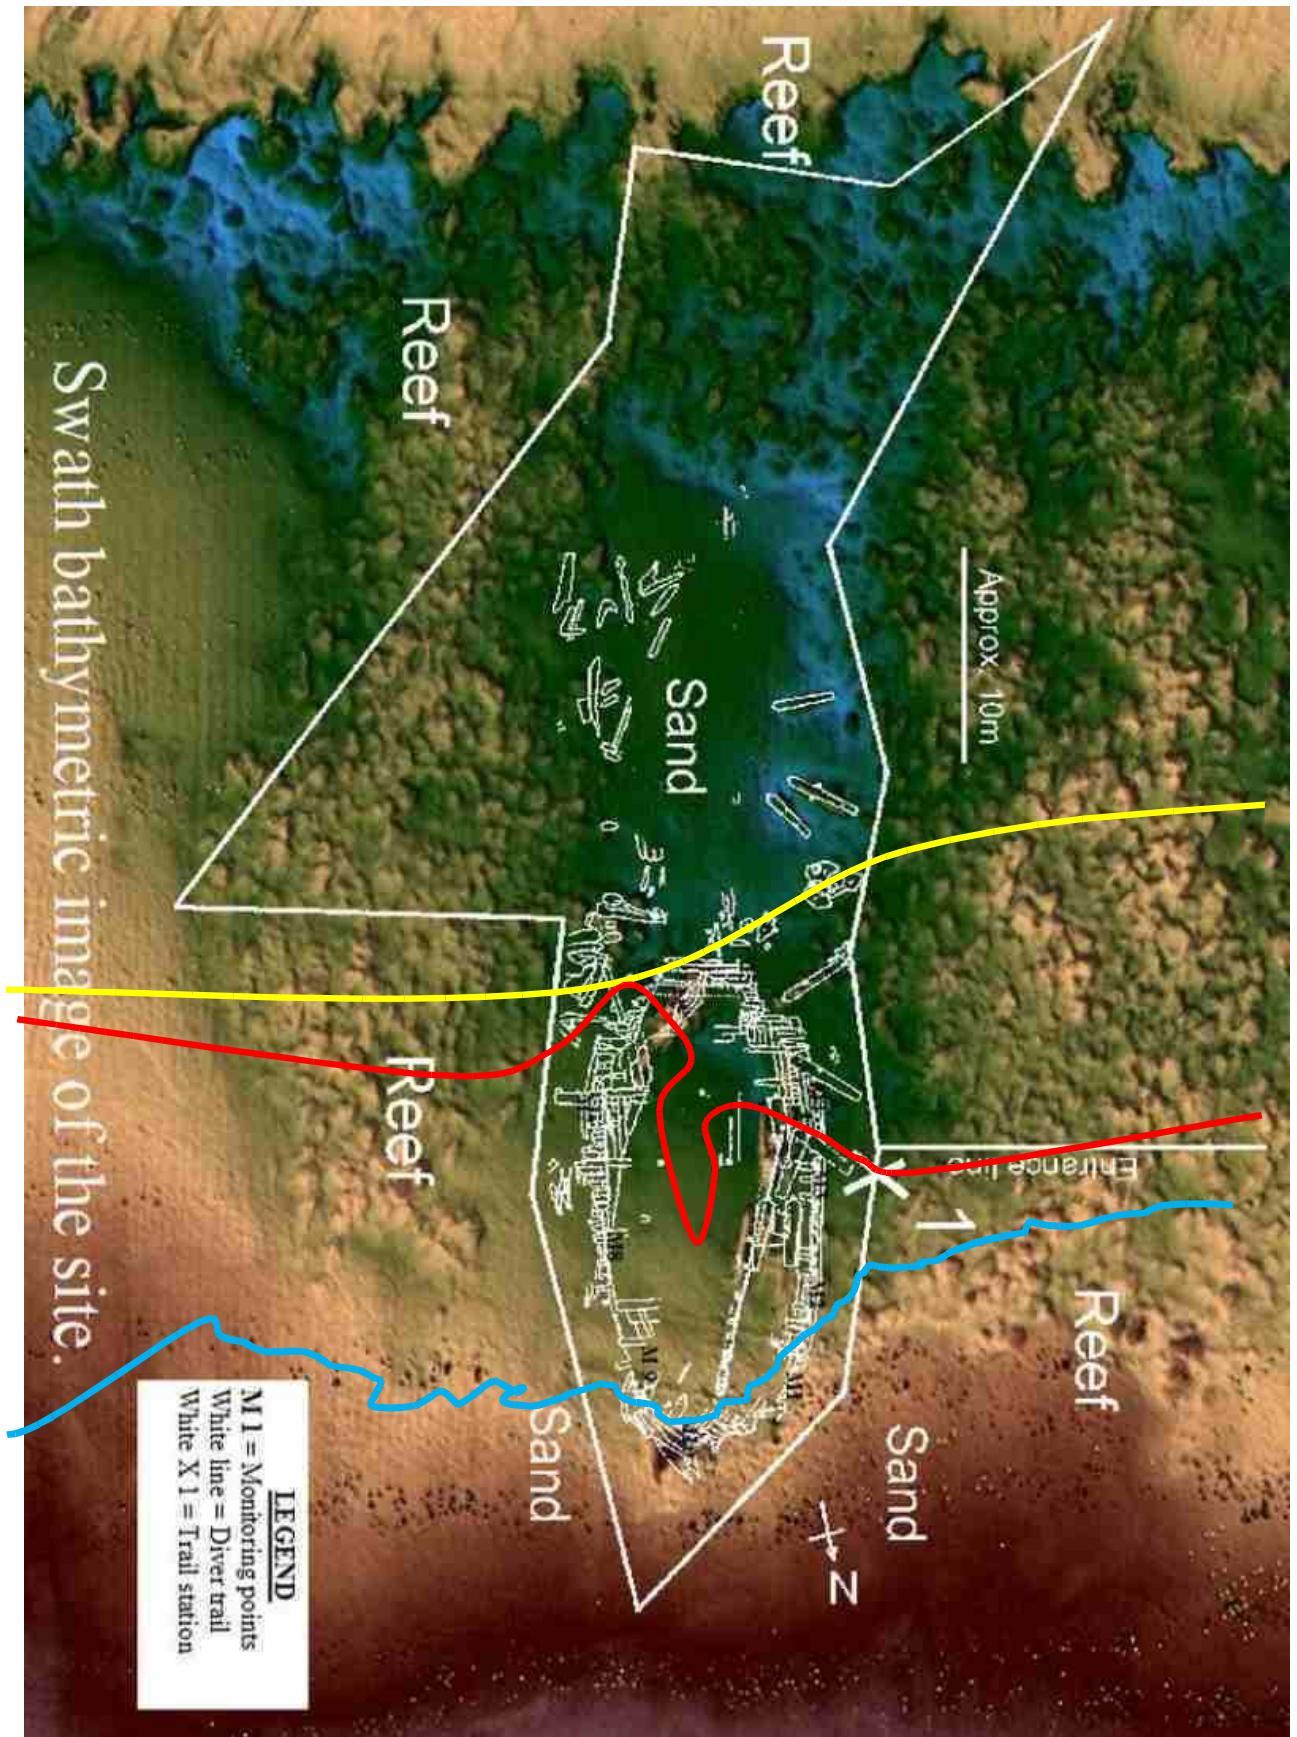
Figure: site plan and diver trail overlain on swath bathymetric survey results. Yellow line = 2008 sand movement from the south to the north. Red line = 2009 sand movement from the south to the north. Blue line = sand movement from the south to the north as at 17th October2010.

The sea bed movement noted over the last two years, south, east and west of the main wreck site, has now increased throughout the whole of the main site, almost completely covering the diver trail. (see fig. 1).

Due to the huge sediment movement over the winter and continued through the summer months, the entire site is now covered with sand to a depth of one metre+ in places (See blue line on site plan showing extent of sediment coverage from the south). This has made it impossible to run the diver trail this season.

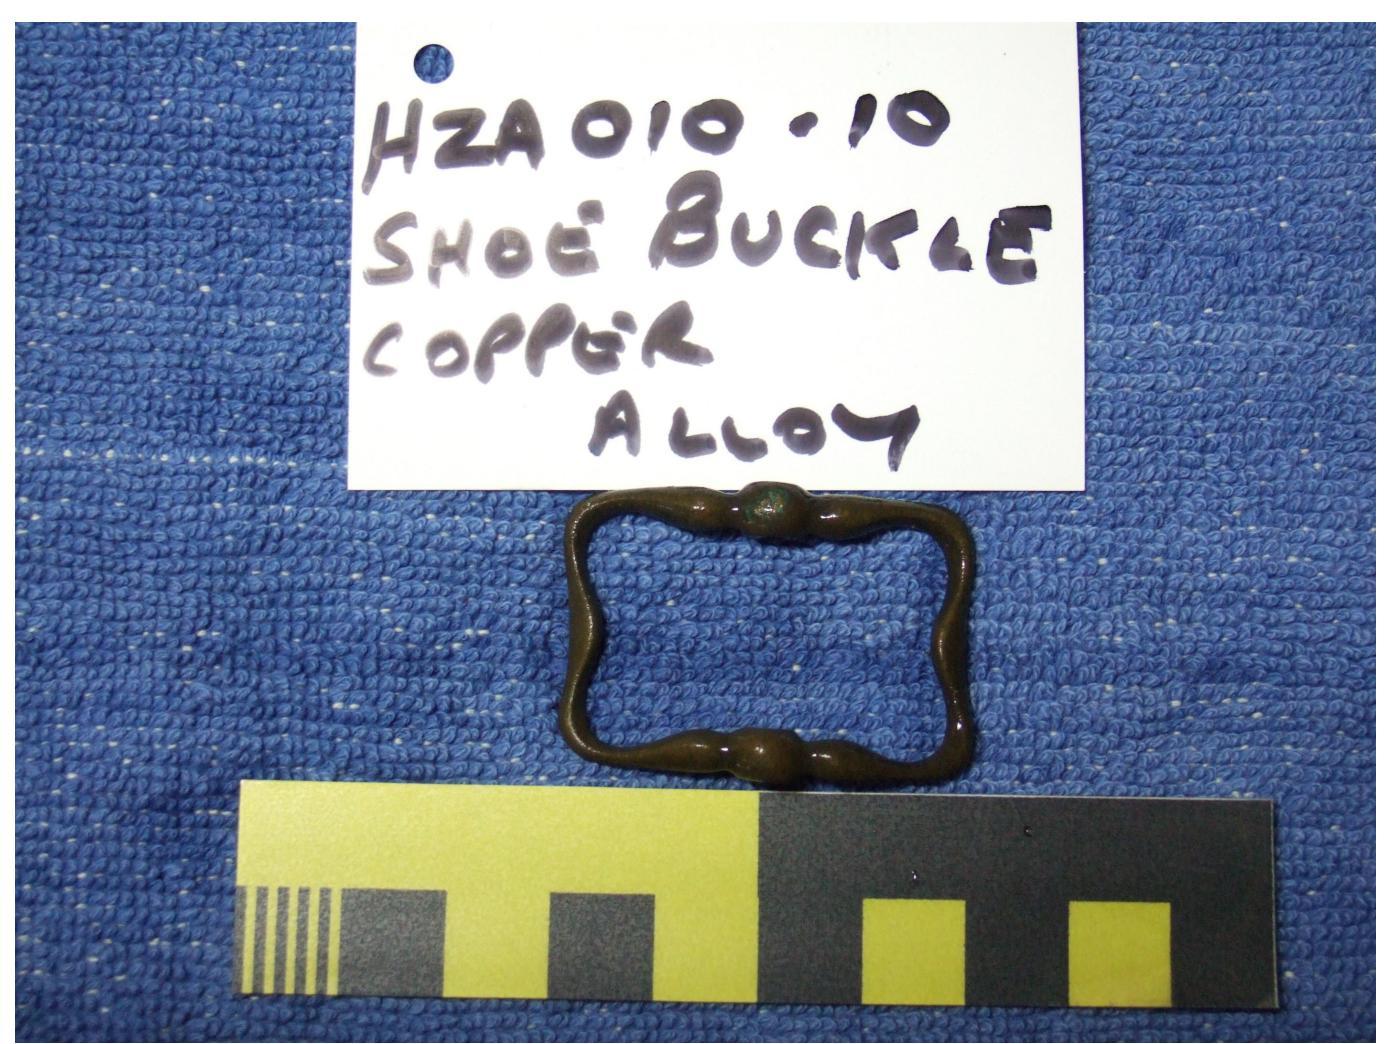
Figure: recovered artefact (from gullies)

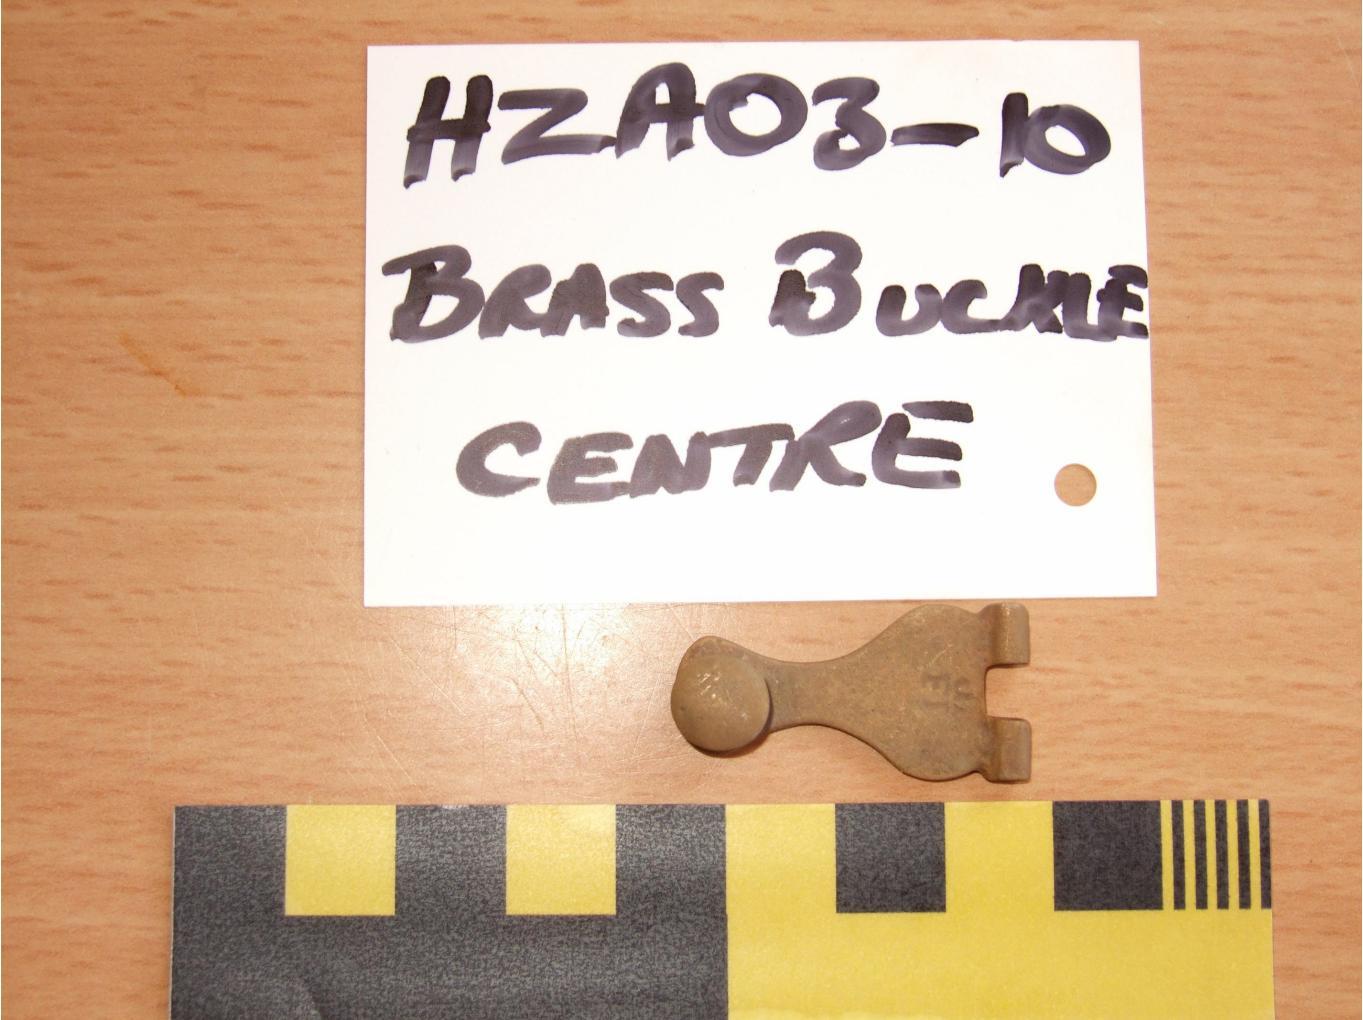
Figure: recovered artefact (from gullies)
