The *Warship Hazardous* Project Site Report November 2015.

Compiled & written by Iain Grant

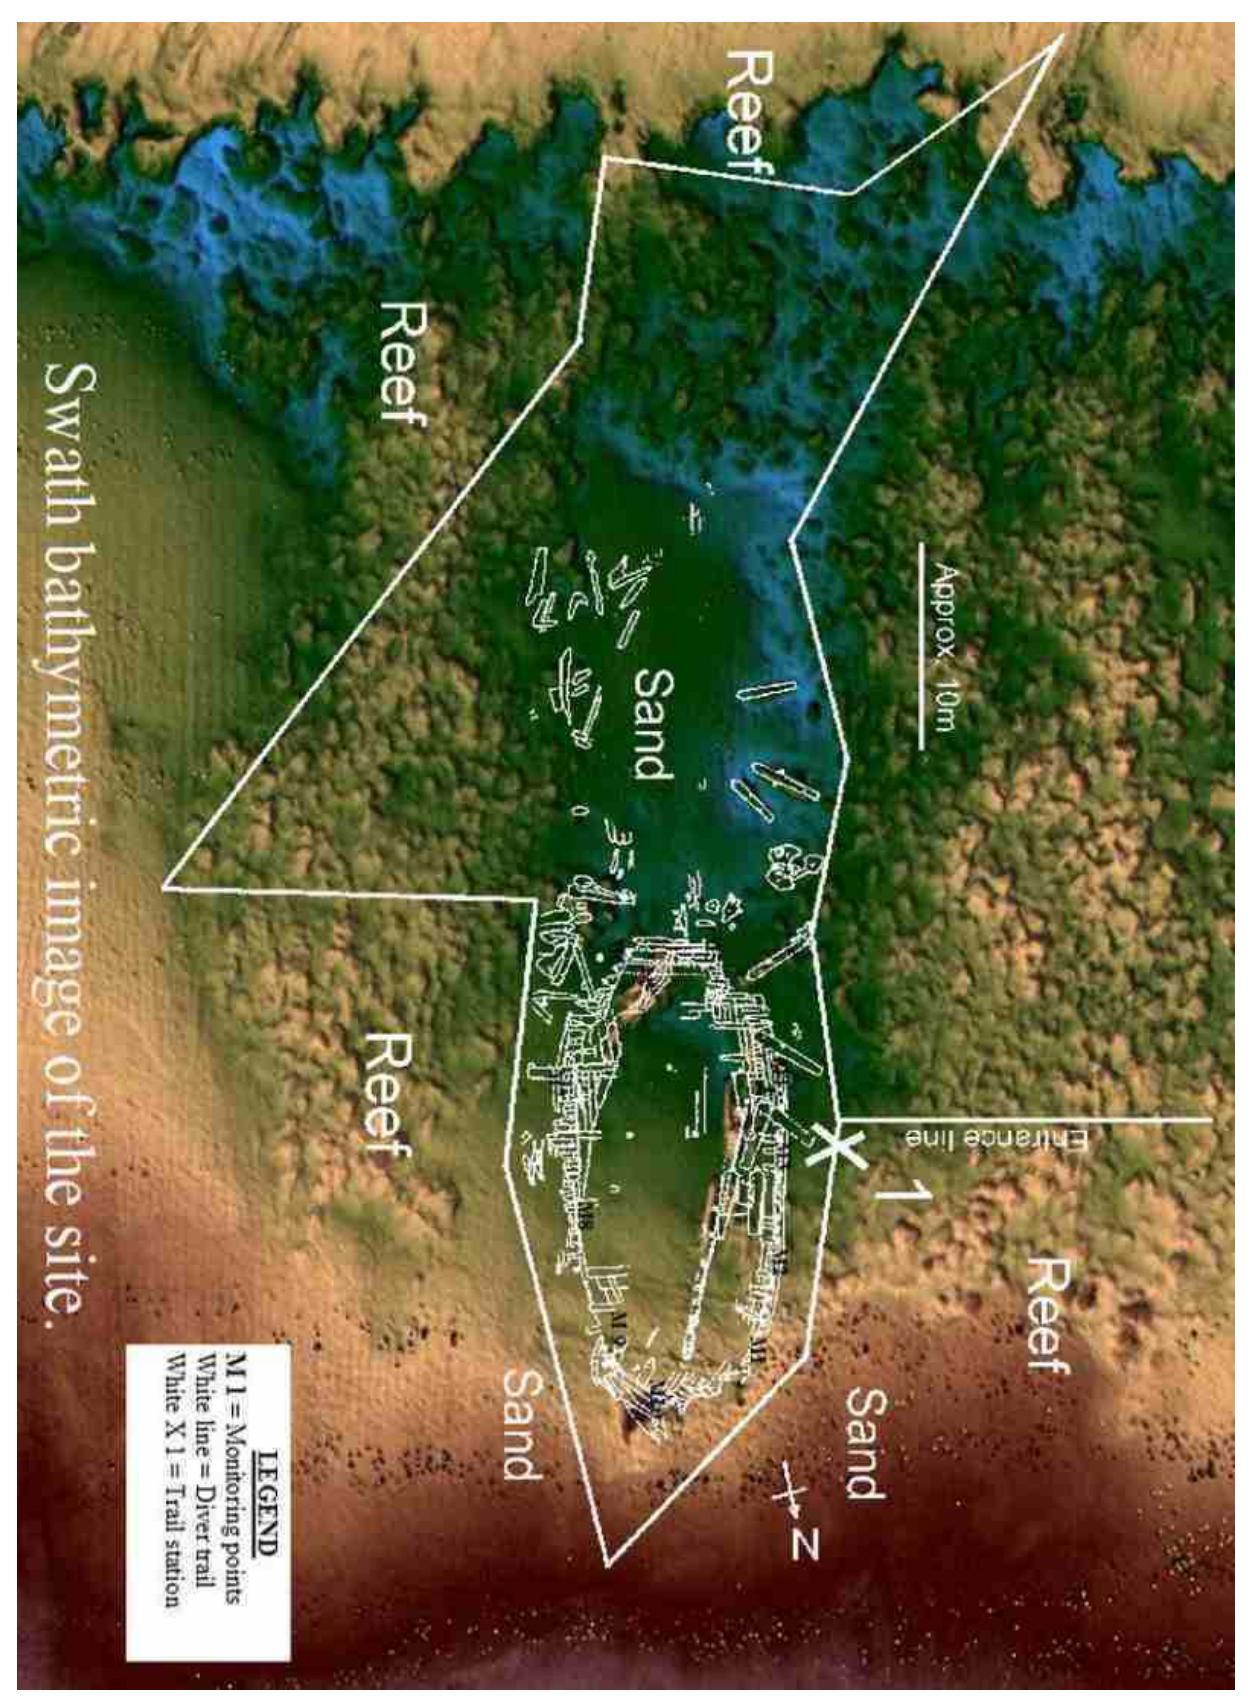
The site is now in an extremely vulnerable position, & we stand to lose much in the way of information as well as degradation, if not complete loss of exposed artefacts over this winter, as they are dispersed over the eastern Solent (*See figure 1&3*).

Figure 1. showing site plan & diver trail overlain on past swath bathymetric survey results.

Yellow line = 2008 sand movement from the south to the north. Red line = 2009 sand movement from the south to the north. Blue line = sand movement from the south to the north as at 17th October2010. Purple line = sand movement from the south to the north as at 21st August 2011. Light brown = 2013 localized scour.

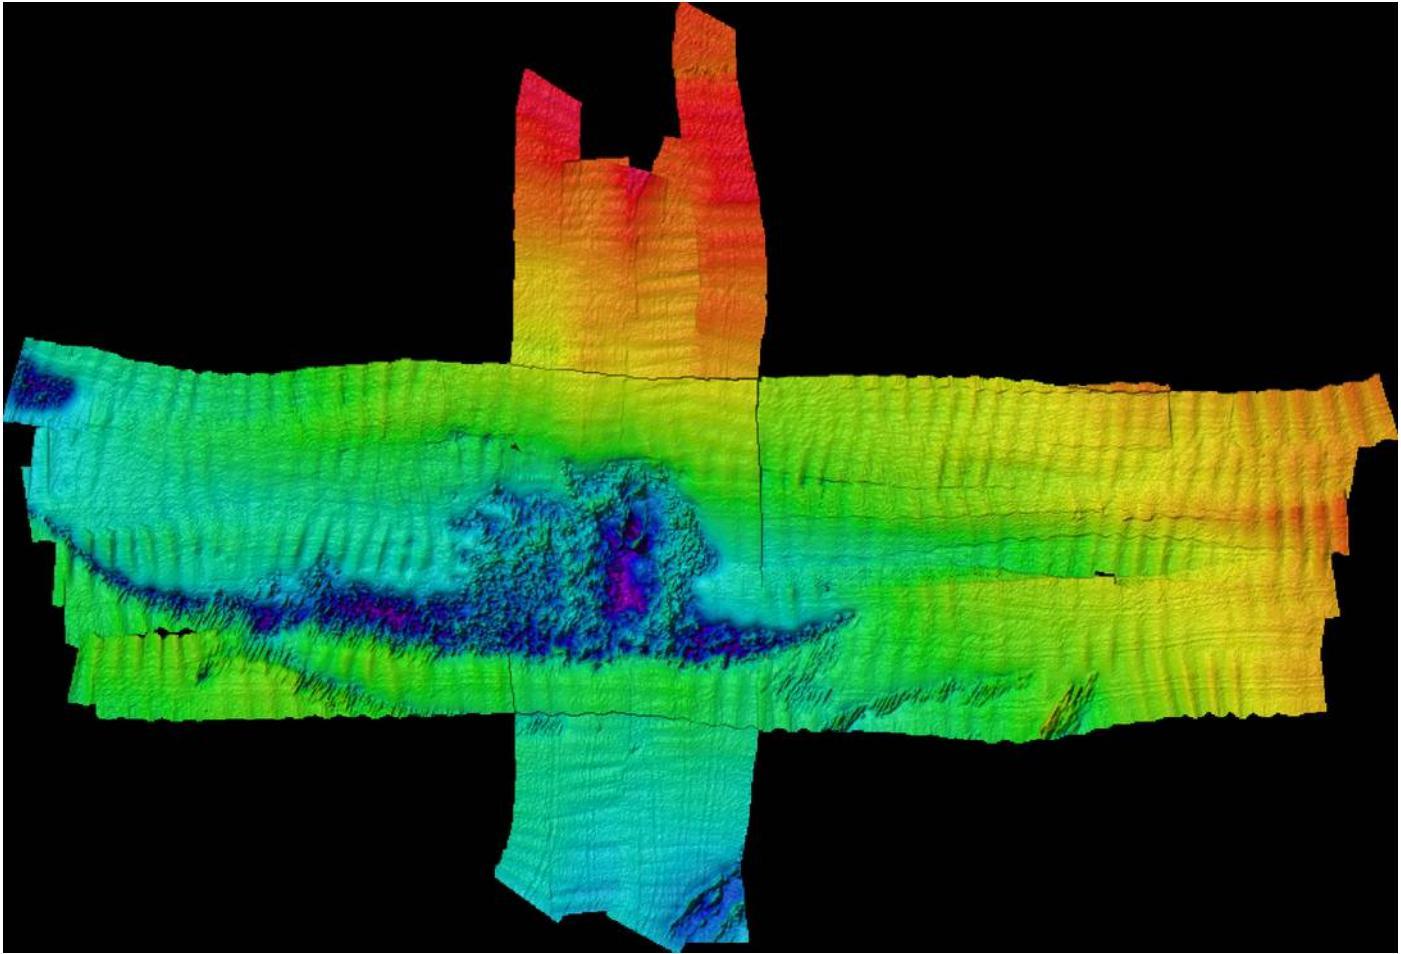
Figure 2. Swath bathymetric survey results July 2014. North up. Showing erosion over the site & out to the west.

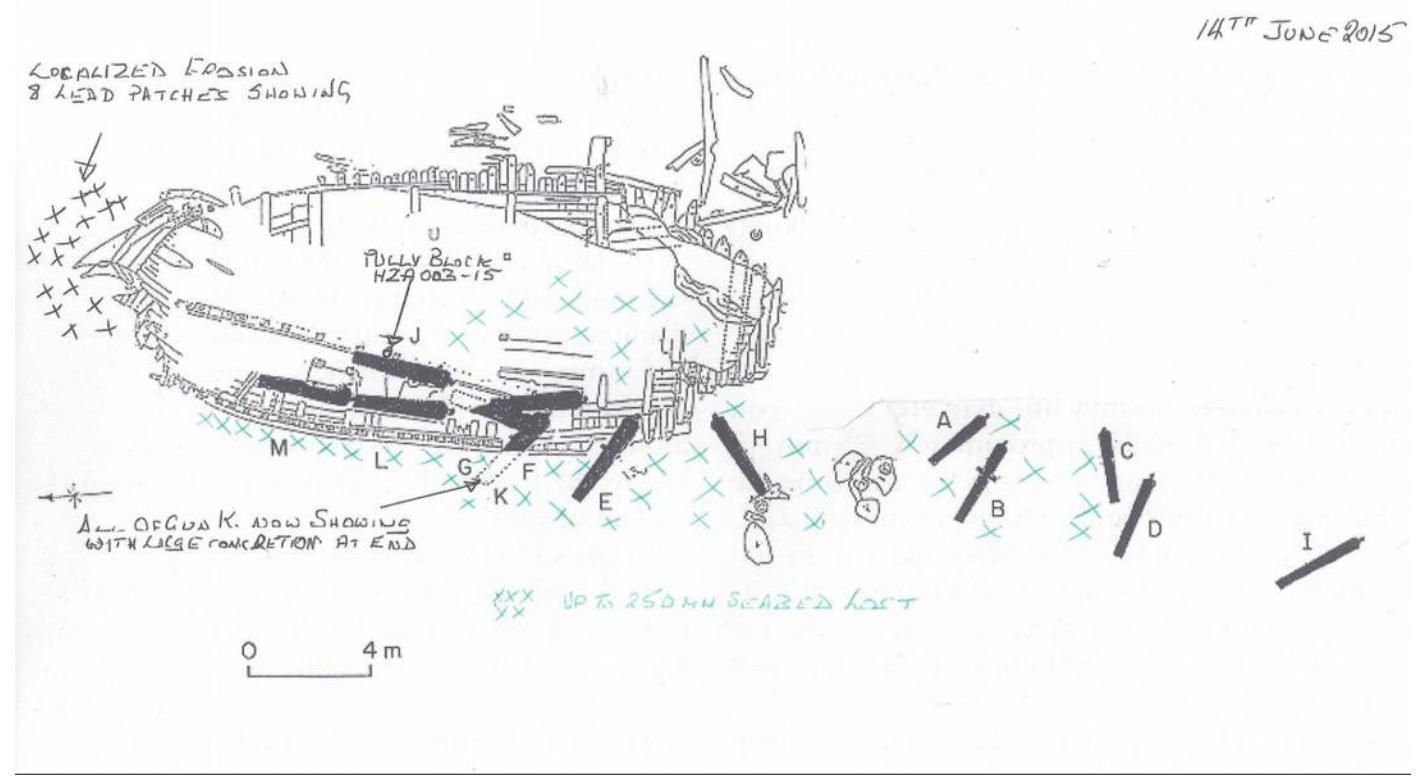
At this time it was also noted that the barrel stave ends visible in the centre of the wreck last season & reported at that time as being more uncovered than 2008, have been again further uncovered over winter, in some places by as much as 100mm (See fig. 3).

Figure 3 Seabed changes June 2015, areas of reduction marked xx, xx.

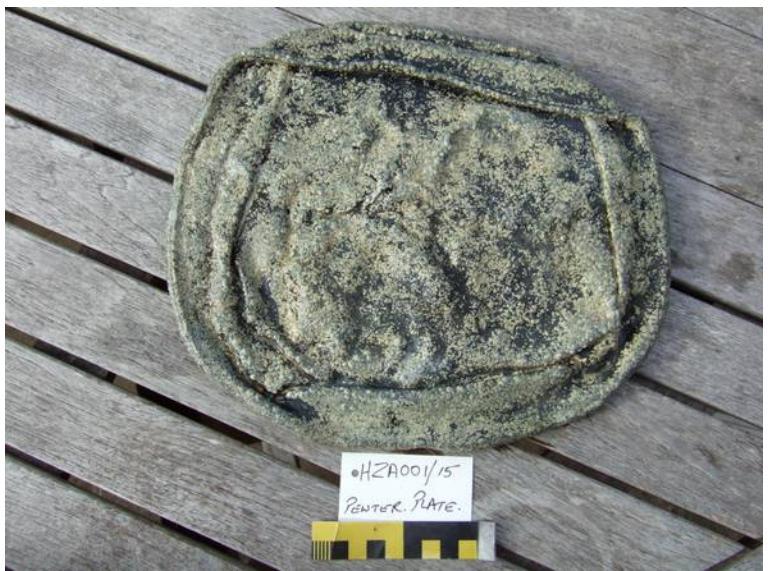
from beneath one of these timbers was a complete pewter plate which has been crushed flat, see *Figure 4*. This artefact was measured in & the position marked to enable extra measurements to be taken in better visibility, it was then recovered to the surface, before it was lost from the site. It was not possible to determine in the poor visibility whether these timbers are "in situ" or have moved to their present position over winter, further evaluation will be undertaken when conditions improve.

Figure 4. Pewter plate recovered 26th April 2015.

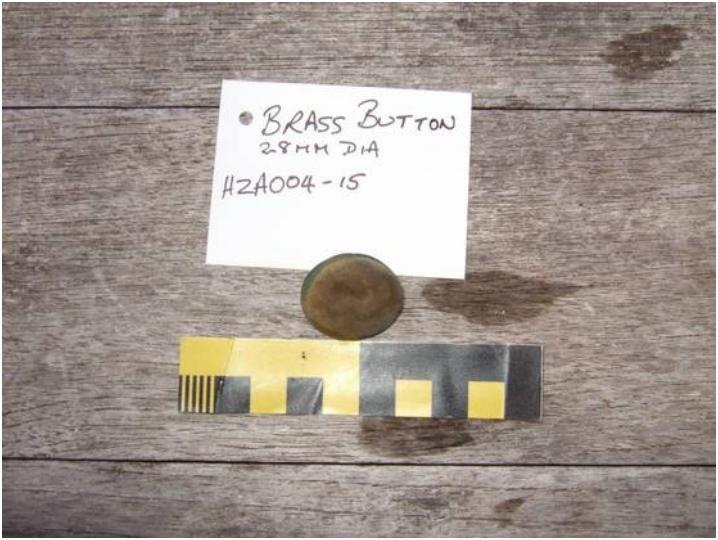
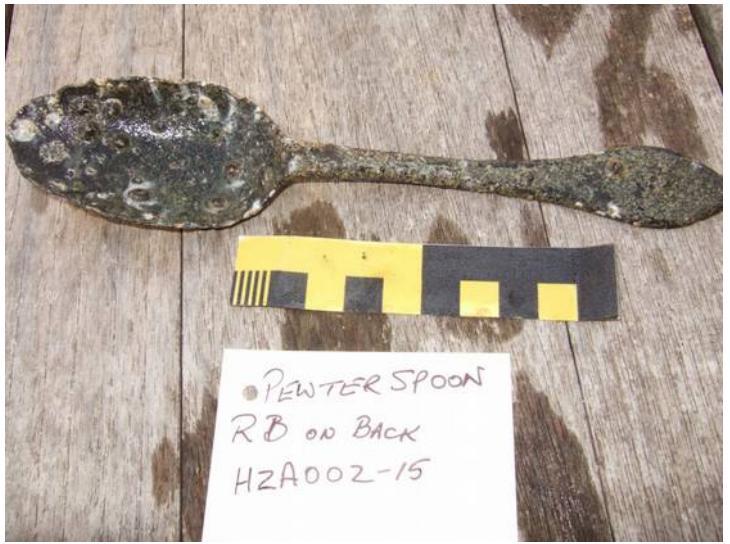
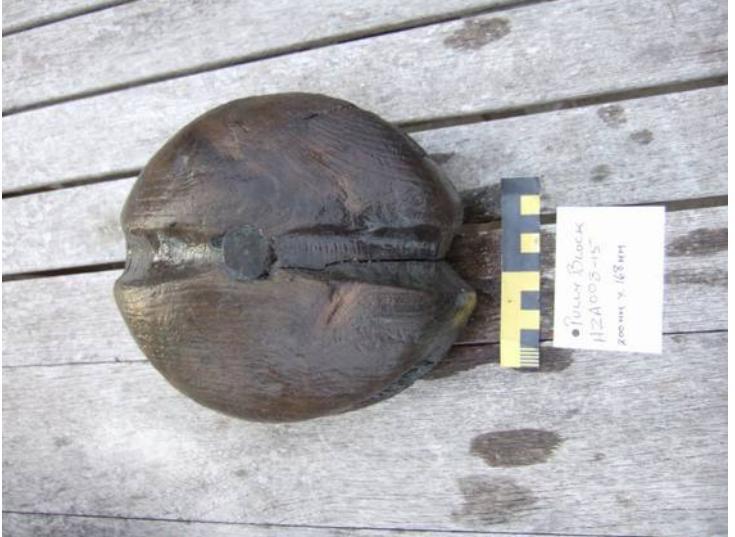
Various shards of glass, earthenware pottery & some animal bone were observed around the site at different times, some textile/leather was also found partially exposed close to the exposed barrels, however as it was in a fragile condition & would require excavation to recover in its entirety (*we do not as yet have an excavation licence*) it was therefore carefully re-buried, it is hoped it will remain in place over winter. Three further at risk artefacts found on the seabed, were recovered from the site this season (see *figures 5 to 7*),

- 1. HZA001.15 Pewter plate.
- 2. HZA002.15 Pewter spoon with RB incised on rear of handle .
- 3. HZA003.15 Wooden pulley block.
- 4. HZA004.15 Brass button 28mm dia.
