The Warship Hazardous Project Site Report - October 2007.

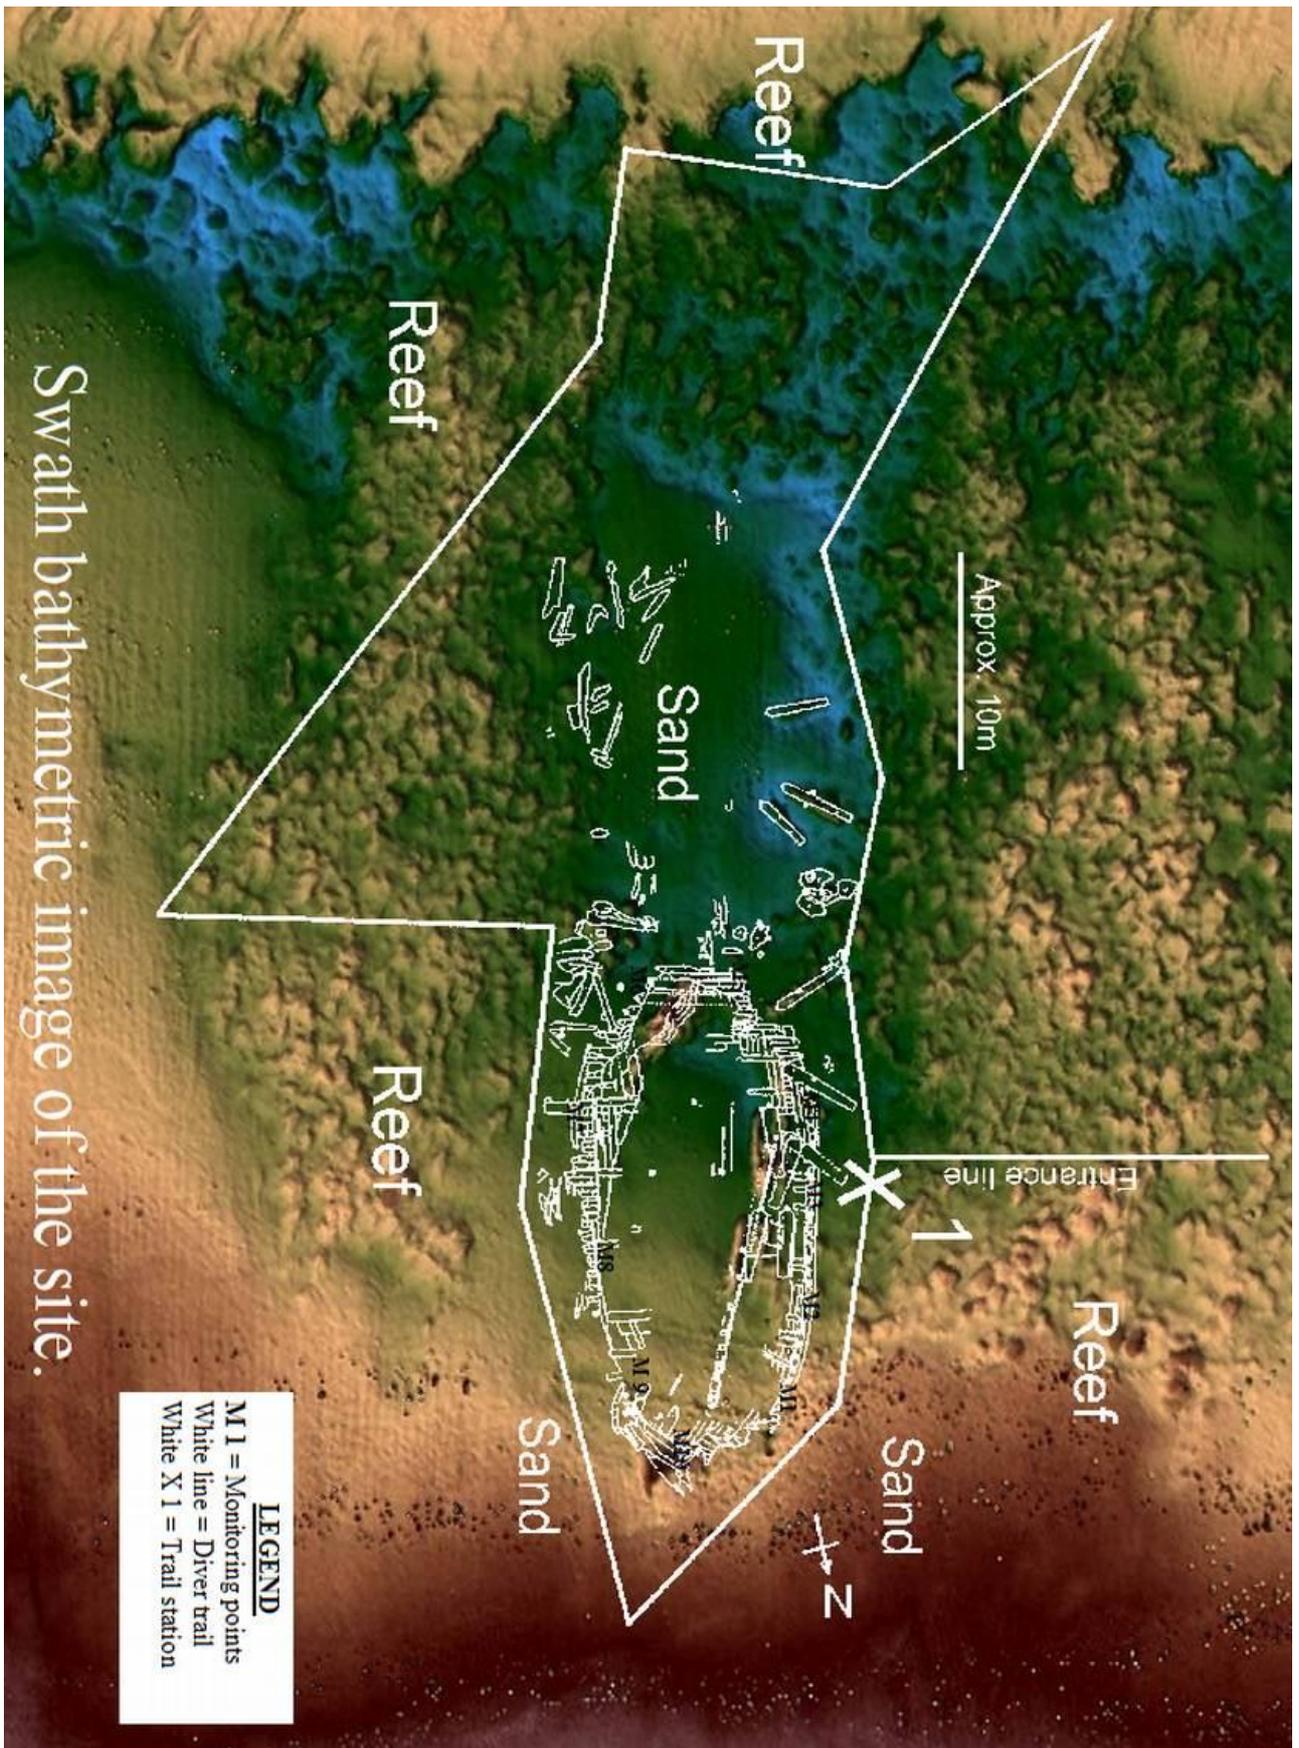
Figure: site plan and diver trail overlain on swath bathymetric survey results.

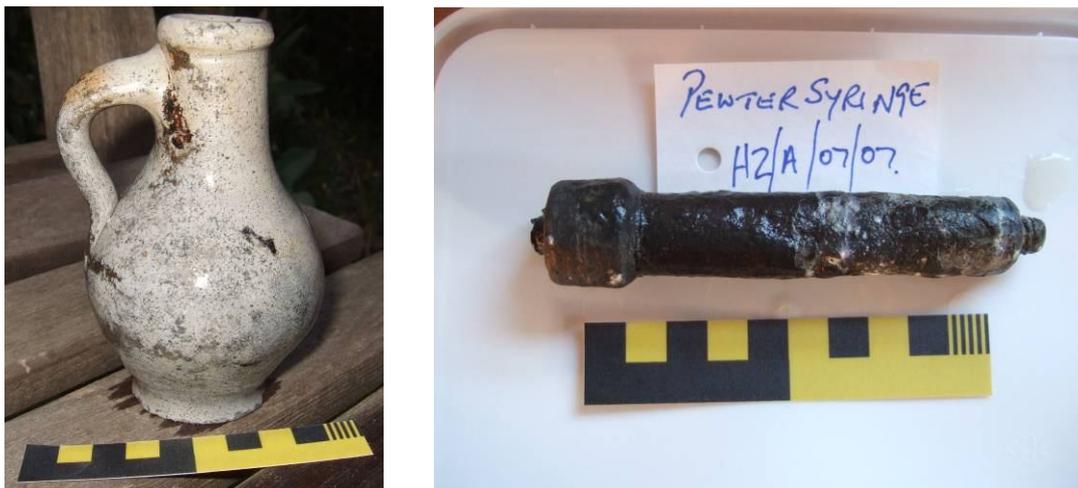
Figure: (left) - pottery vessel recovered from site (right) pewter syringe recovered from site

A complete earthenware pot, grey in colour and 121mm high x 75mm diameter at it's widest point was measured into the site and recovered from a position 4.3 metres north of the beak (see figure 2).

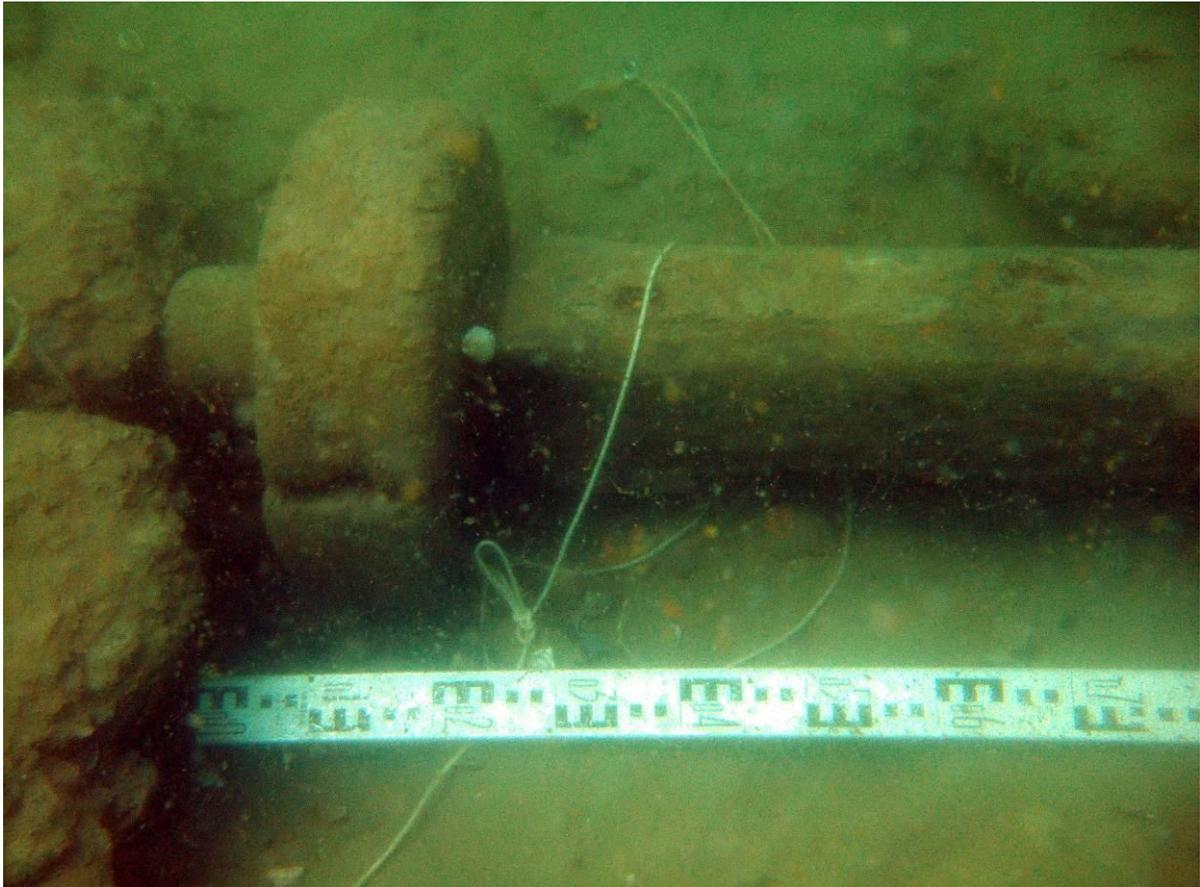
Figure: gun carriage axle complete with wheel *in-situ*.

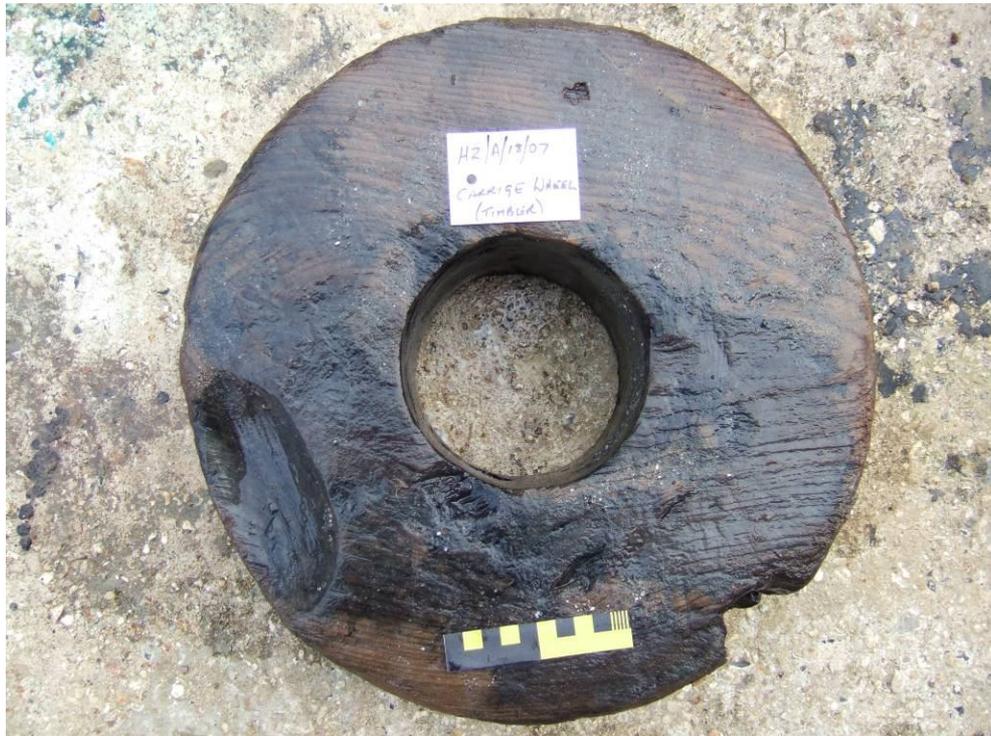
Figure: gun carriage wheel.

The gun and carriage that was sheeted and buried after the trench excavation in the early nineties, has become partially uncovered to show the rear wheel and the stepped area of the carriage cheek. In the same area there is a wooden carriage wheel partially uncover and unattached (see figure 5).
